Solution Guide

uni MPB C
Straight Running Belt

Industry > **Poultry**

Application > **Cage Dump**

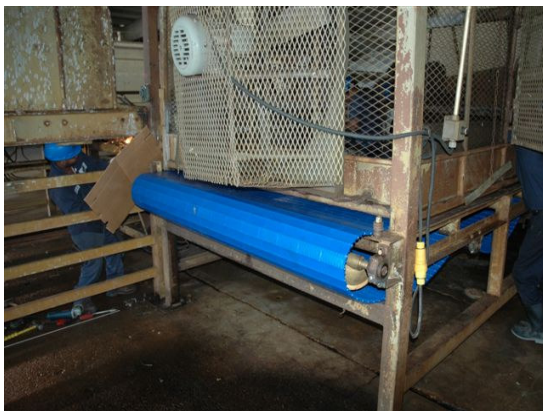
uni MPB in PEI blue material on a cage dump conveyor

uni MPB closed top in PEI blue is used to withstand the outdoor temperature range, provide some UV protection and resist chemical attack of the bird waste. Typically SS sliding surfaces are used and softer PEI material embeds with the gritty material and makes a good wear combination.

uni MPB closed top provides continuous a closed top surface for the birds to walk on without becoming stuck or caught in the belt. The open hinge design creates a gap in between the hinges as the belt pivots around the sprockets, so if a foot does get stuck it is released at the sprocket area.

Nylon PA6.6 lockpins are used to withstand to the wear of the embedded PEI material and the easy maintenance of the lockpin design makes size adjustment of the belt much easier when necessary. An auger style idler removes debris from under the belt and sprocket wear is greatly reduced by using our standard nylon PA6.6 sprockets.
