Solution Guide

uni MPB 22% open
Straight Running Belt

- Industry > **Poultry**
- Application > **Chiller Discharge**
- Description > **Whole birds are taken out of the chiller bath**

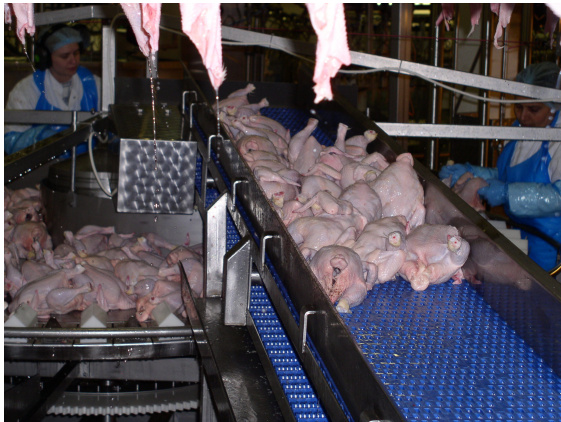
This is usually an incline conveyor that takes the whole birds out of the chiller bath. The open belt in this application also dewateres the birds as they are conveyed.

uni MPB 22% open on a chiller discharge conveyor
