# Solution Guide

uni MPB C  
Straight Running Belt

- Industry > **Snack Food**
- Application > **Potato Chip Inspection Conveyor**
- Description > **Chips are inspected for blemishes and sorted**

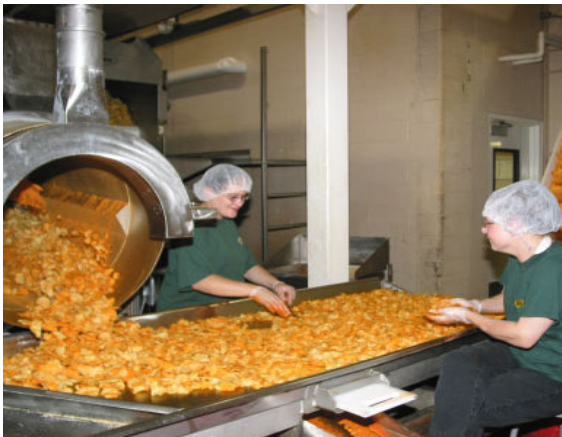
*Inspections can be done by hand or with the help of photo eye equipment.*
