Solution Guide

uni CNB 22% open
Straight Running Belt

- Industry > **Snack Food**
- Application > **Tortilla Chip Transfer Conveyor**
- Description > **Tortilla Chips are Transferred to Packaging Line**

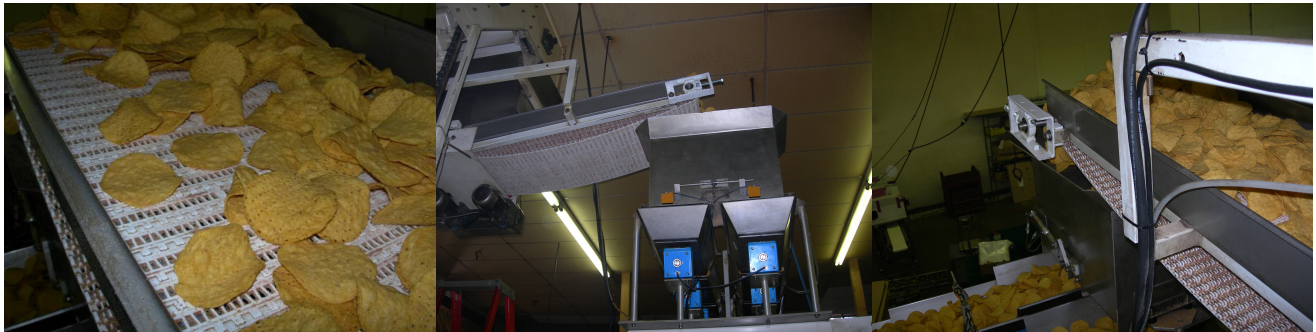
The customer manufactures corn tortillas and corn chips. This small conveyor transfers the warm chips from the cooler conveyor to the scale above the form-fill-seal bagging equipment.

uni CNB 22% open in PP material with PA6.6 pins

Ammeraal Beltech Modular provided a uni CNB 22% PP belt with PA6.6 lockpins and sprockets to match the diameter of the drive and idler pulleys. The positive tracking of the sprockets hold the belt in place and eliminate the tracking problems. The uni belt has been running for more than one year non-stop without any problems.
